HCAT/JCAT Program Review Meeting

*San Diego, CA
25 January 2006*

PERFORMANCE ASSESSMENT OF TWO DIFFERENT AVIATION CARC COATING SYSTEMS ON STEEL WHEN CADMIUM PLATING IS ELIMINATED

U.S. Army Research Laboratory

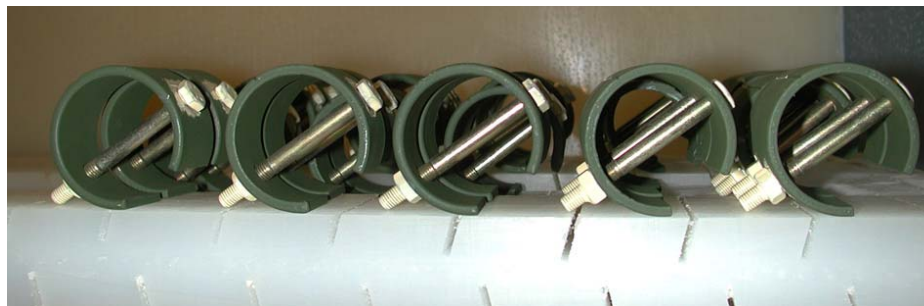
Hydraulic Adhesion Apparatus Test Kit

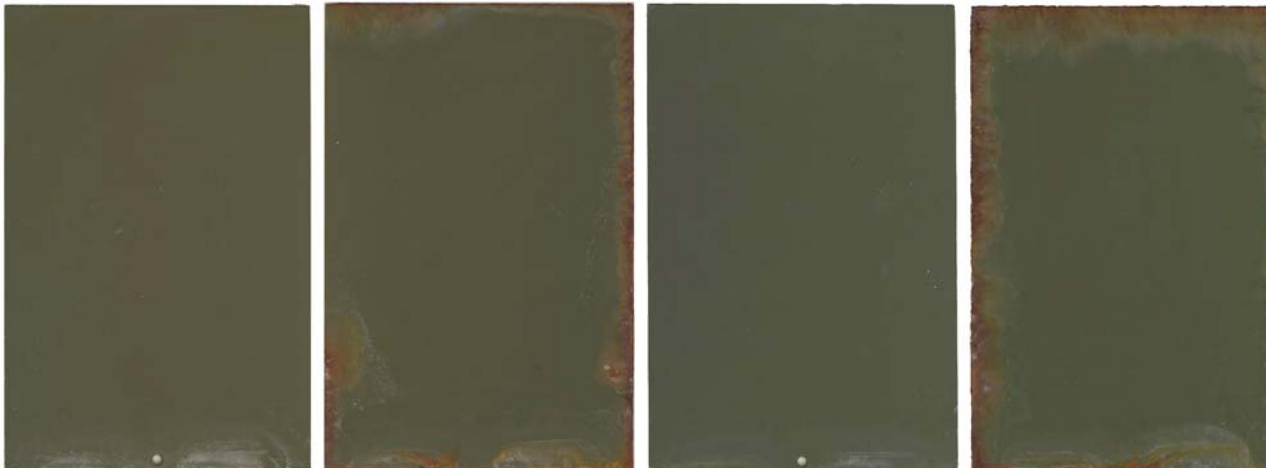
- Topcoated sides faced inwards
- Scribed panels “X” scribes were offset

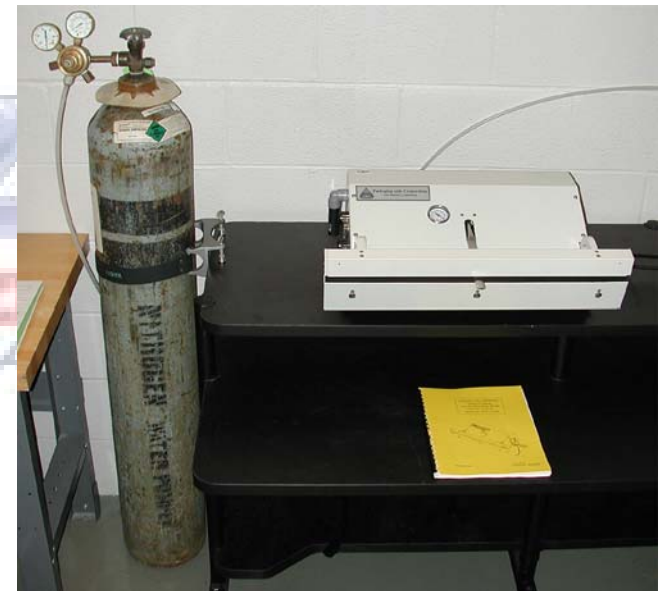
Packaging Aids Corporation
Series 88 Tabletop Vacuum
Impulse Sealer with N₂ Backfill

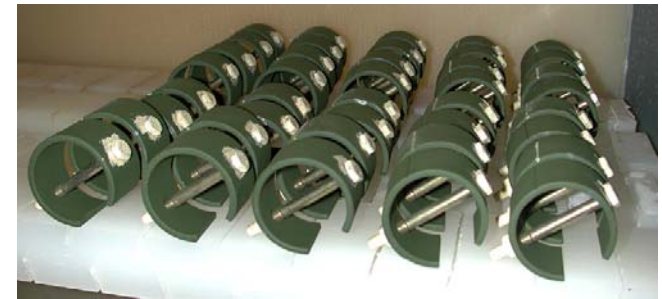
- Type 1d C-rings
- AISI 4340 @HRC 52
- Sensitivity performed in accordance with ASTM-F-519
- C-rings passed 75% load in air for unplated and dull Cd
- C-ring test load set at 40% UTS after sub 200 hour failures in air at:
 - 65%
 - 50%for SAE AMS QQ-P-416, Type II, Class II plated C-rings
- Coating Systems 1 - 4
 - Damaged coating over notch
 - Undamaged coating over notch
- Run to fracture under GM 9540P

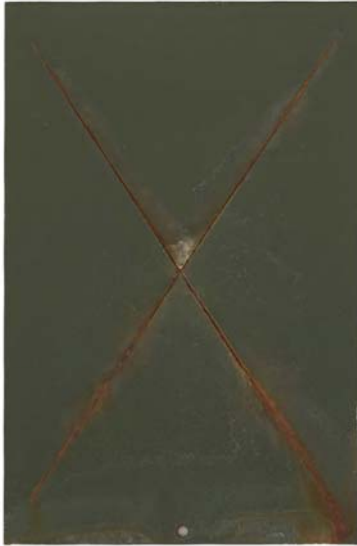
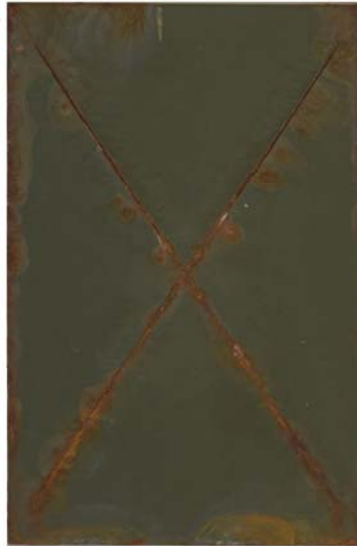
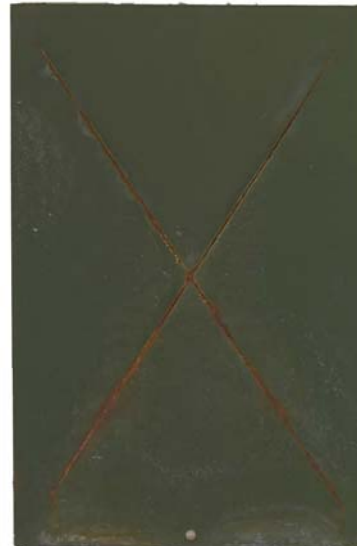
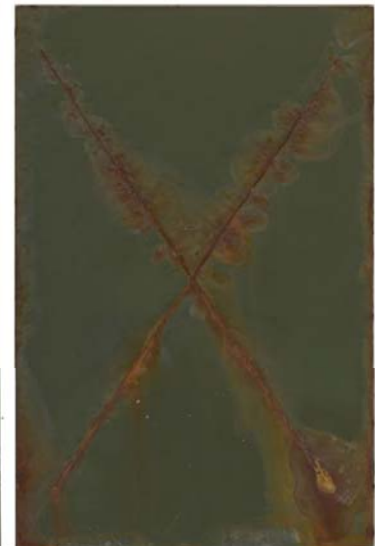
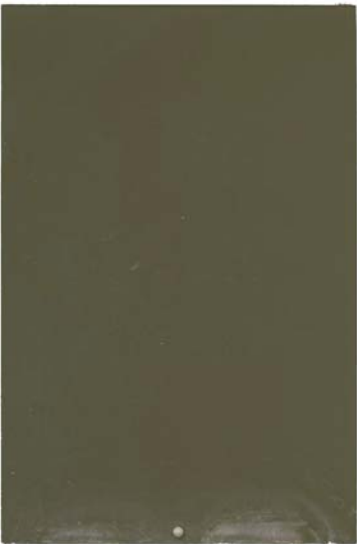
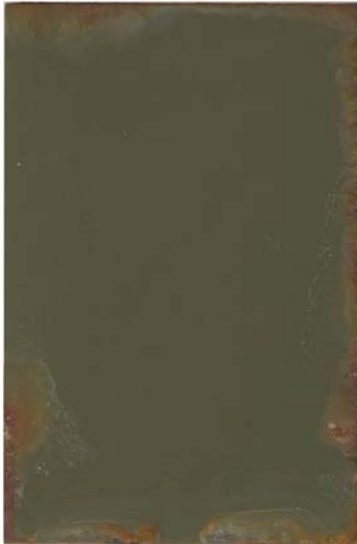
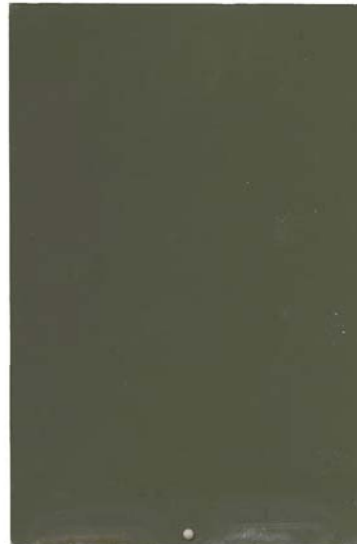
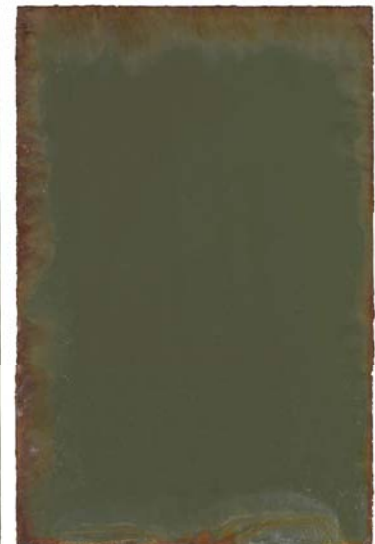
Coating System 1 @80 cycles

Coating System 2 @50 cycles

Coating System 3 @80 cycles

Coating System 4 @50 cycles

Coating System 2 @80 cycles

Coating System 4 @80 cycles

- Corrosion damage on scribed panels only
- Unscribed panels were undamaged - even after 80 cycles
- Major variations depending on coating system for scribed panels
- Coating system 1 had superior performance
- Coating system 3 performed excellent
- Comparable Performance for systems 2 and 4 but much worse than systems 1 and 3
- Cadmium plating was obviously the key

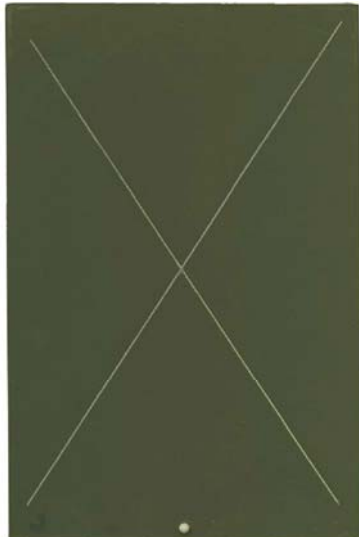
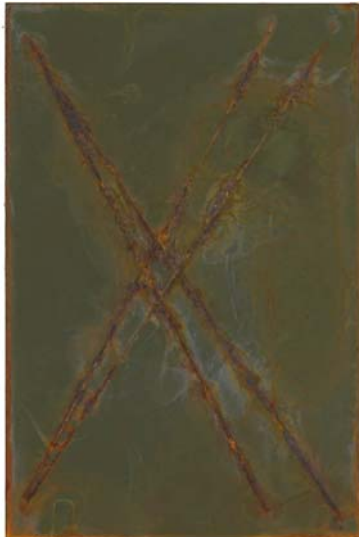
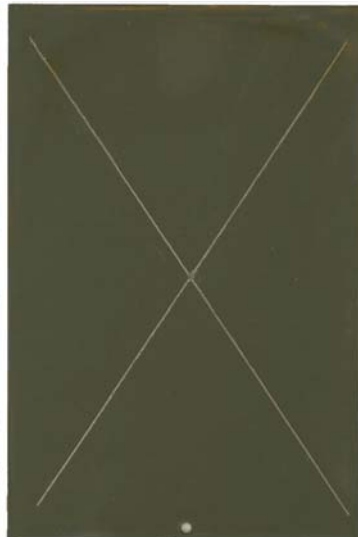
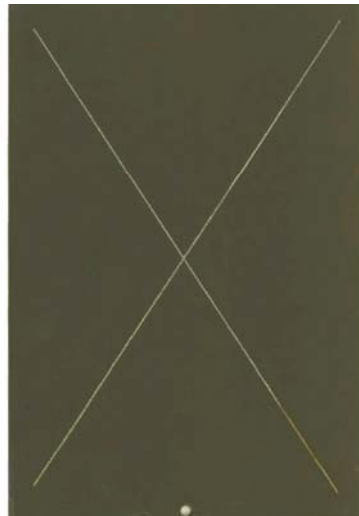
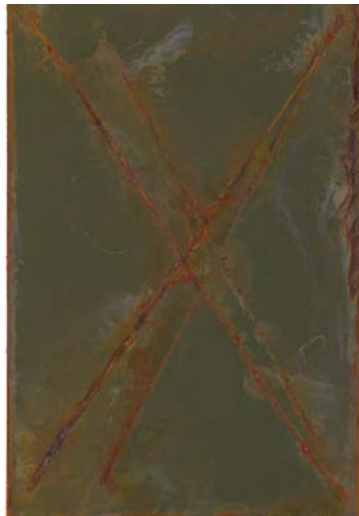
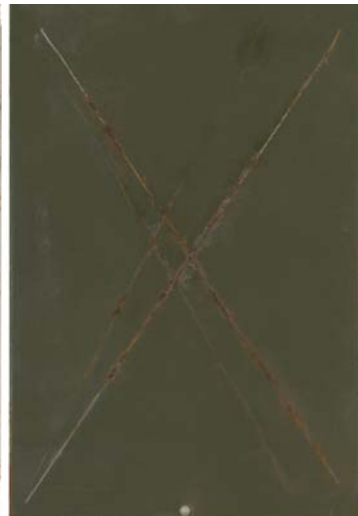
Coating System 1 @ 10 cycles

Coating System 2 @ 10 cycles

Coating System 1 @ 50 cycles

Coating System 3 @ 10 cycles

Coating System 4 @ 10 cycles

Coating System 3 @ 50 cycles

- Coatings systems 1 and 3 better @ 50 cycles than coating systems 2 and 4 @ 10 cycles
- Cd plating again superior
- Chromated primer gives slight performance edge

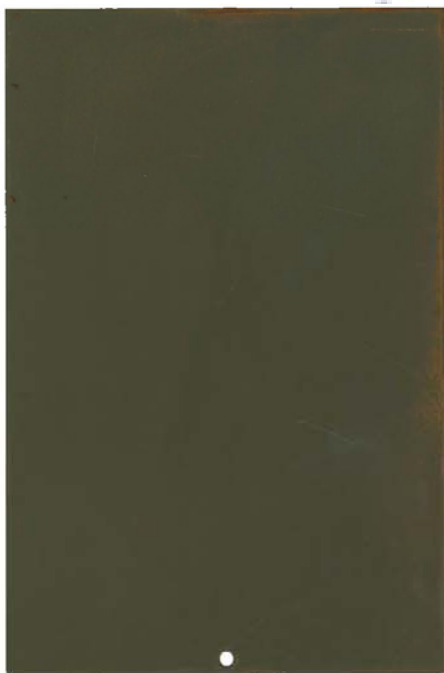
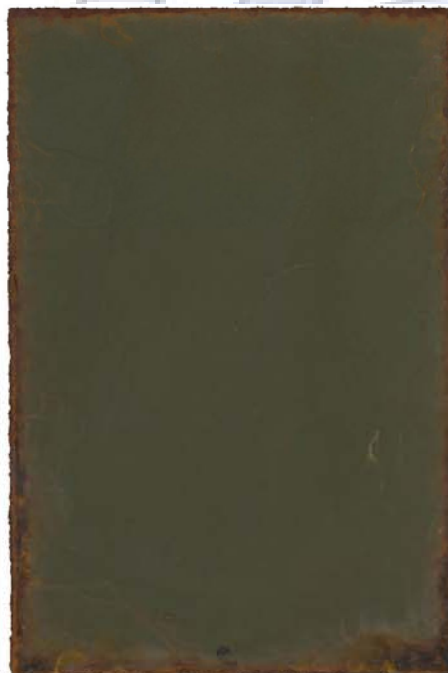
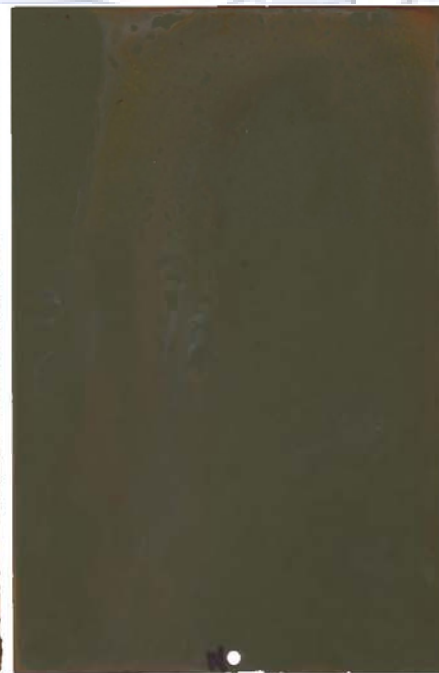
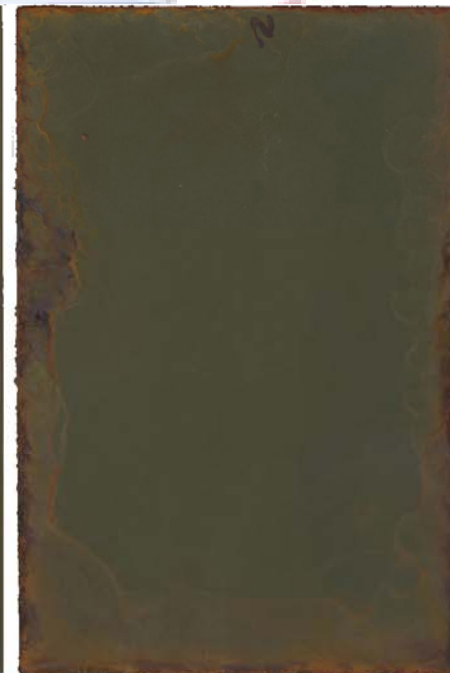
Coating System 1 @60 cycles

Coating System 2 @60 cycles

Coating System 3 @60 cycles

Coating System 4 @60 cycles

- Coatings systems 1 and 3 performed best and were comparable
- Chromated primer did not seem to enhance corrosion resistance for either Cd plated or unplated conditions

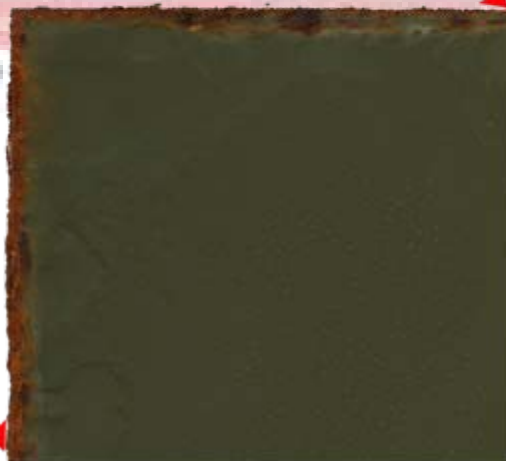
40 Cycle GM 9540P Exposure Unscribed Crevice Corrosion
with Coating Blistering at 3X Mag. (relative) for Coating System 2.

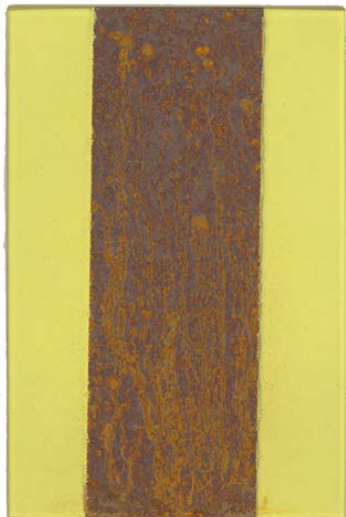
- Complete corrosion of masked regions prior to completion of (1) GM 9540P cycle
- No difference when chromated vs. nonchromated
- No difference when topcoated vs. primer coating only

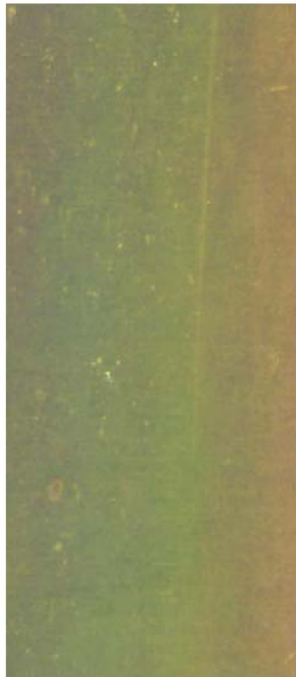
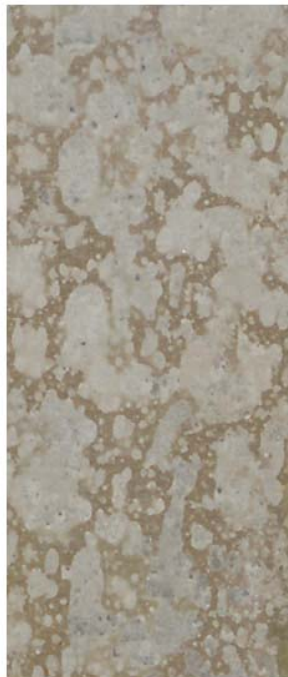
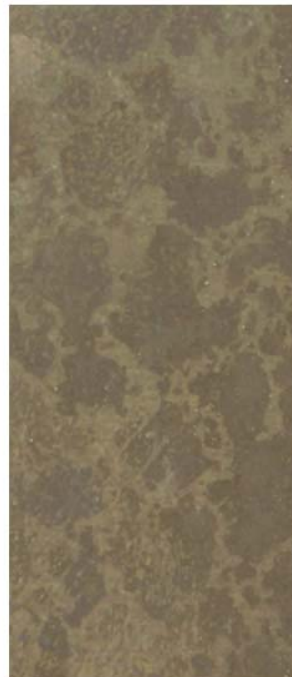
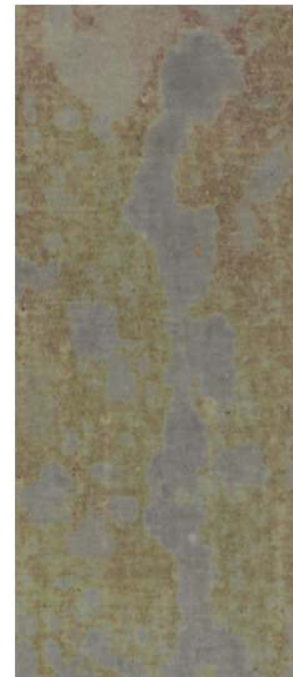
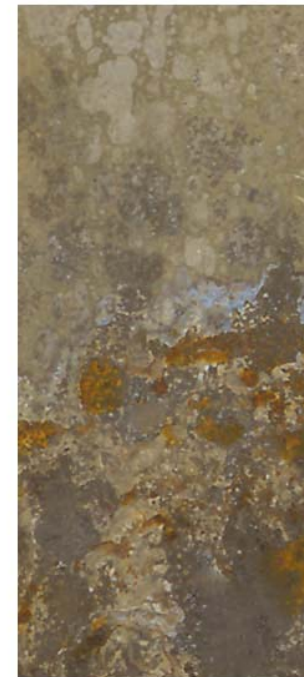
Typical progression of cadmium plating breakdown

Initial

White Cadmium
Corrosion Products
and Blotching,

Dark Gray to Black
Blotches of Oxidized
Cadmium

Exposed Areas of
Gray Unrusting Steel
or Chromate Depleted
Cadmium Plating

Final Rusting of
Steel Substrate

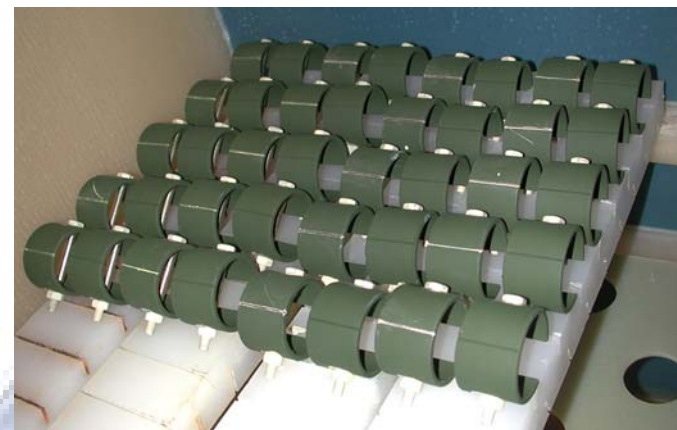
Type 1d Specimens - Cd Plated - Notched Rods - Sensitivity and Test Load Calibration					
Specimen Number	Beginning Width (in)	Loaded Width (in)	Percent of UTS	Displacement @ Load (in)	Hours Until Failure
Bright Cd1	1.962	1.863	75	0.099	< 1
Bright Cd2	1.962	1.863	75	0.099	< 1
Bright Cd3	1.962	1.863	75	0.099	< 1
Dull Cd1	1.962	1.863	75	0.099	> 200
Dull Cd2	1.962	1.863	75	0.099	> 200
Dull Cd3	1.963	1.864	75	0.099	> 200
Plain 1	1.966	1.867	75	0.099	Did Not Fail
Plain 2	1.968	1.869	75	0.099	Did Not Fail
Plain 3	1.968	1.869	75	0.099	Did Not Fail
SAE AMS QQ-P-416 #1	1.968	1.882	65	0.086	< 6
SAE AMS QQ-P-416 #2	1.970	1.884	65	0.086	< 6
SAE AMS QQ-P-416 #3	1.971	1.885	65	0.086	< 6
SAE AMS QQ-P-416 #4	1.964	1.898	50	0.066	< 24
SAE AMS QQ-P-416 #5	1.970	1.917	40	0.053	> 200*

* Used as basis for loading of C-ring test matrix

- Pre-existing hydrogen from defective bath or failure to hydrogen relief bake within the 4 hour window on Cd plated C-rings

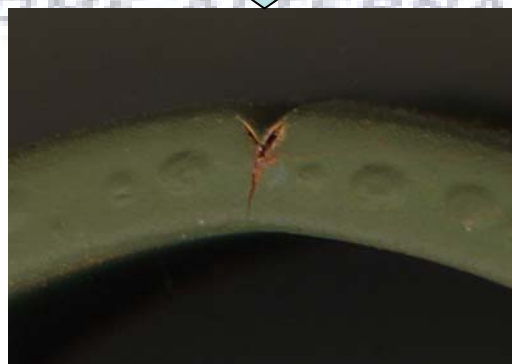
4 Cycles (7X)

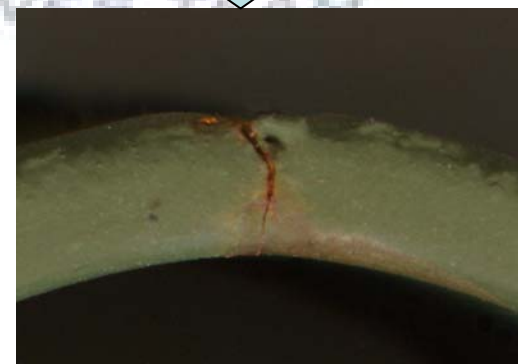
48 Cycles (7X)
